Upon the reinspection of the repairs to the flashing at the lower roof/siding transition on the right side of the front porch the water intrusion issues inside the stucco appear to be still present.

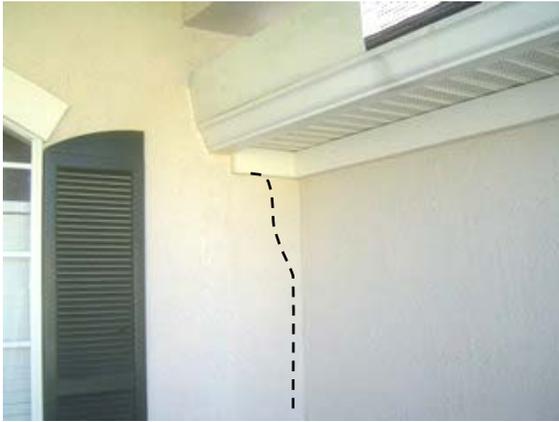
- ◆ The stucco cracking noted at the 1st inspection appeared to be slightly larger,
- ◆ The homeowner stated when viewed from the attic there is discolored wood/decking visible at the area of flashing,
- ◆ Water intrusion appears across the base of the stucco wall to the right of the front window under the area of flashing,
- ◆ When the carpeting in the interior room adjacent to the area of concern was pulled back the tack strips were discolored from moisture exposure, and
- ◆ Elevated levels of moisture (27% +/-) were noted in the ¼-round trim and baseboards.

At the time of the reinspection on 10/13/07 the repair to the flashing to address the original inspection findings do not appear to have been effective.

It is suggested a licensed contractor and/or roofer be consulted for further evaluation and repair as required.

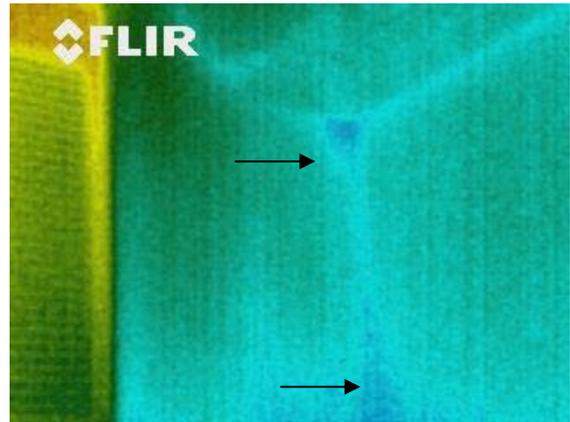
When infrared imaging was performed the level of water exposure in the stucco under the flashing appears to have shrunk in size but now there is water accumulating in the corner and along the base of the wall under the same area.

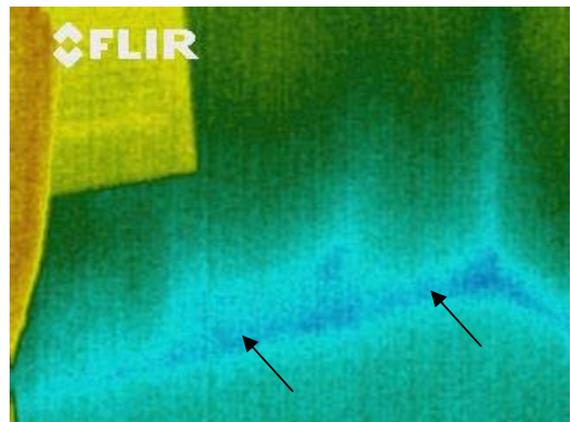
“Blue” areas indicate elevated levels of moisture in the stucco along the base of the wall the tack strips. ¼-round trim, and baseboards inside the room adjacent to this area show evidence of moisture exposure.

Drilling a couple of “weep” holes into the stucco may alleviate the accumulation of moisture along the base of the walls. The “weep” holes should be just above the porch floor, angled slightly upwards, and no deeper than required (7/8”-1” deep).

“Weep” holes will not solve the water intrusion issues but may slow down intrusion inside the house until repairs can be made.

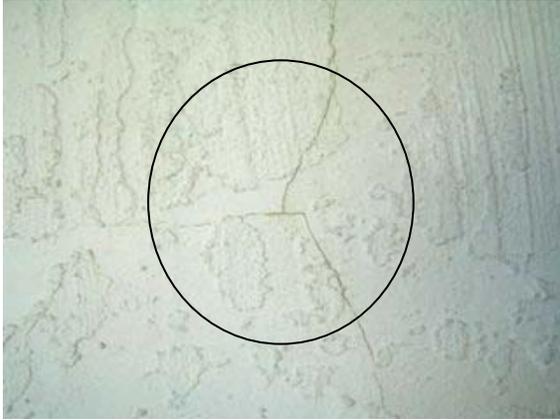
Area of stucco cracking noted below the gutter on the right side of the front porch. Cracking appears slightly larger than initial inspection.

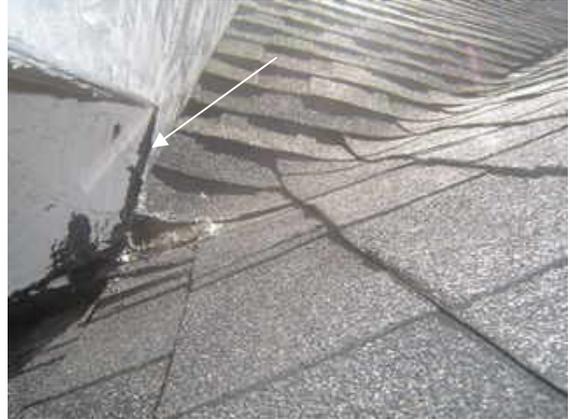
Close look at heavily tarred area of 5x5 flashing where it is suspected water intrusion was initially occurring.

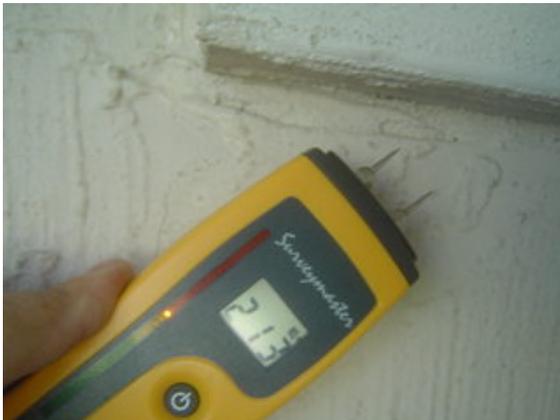
Moisture levels in the stucco below the gutter on the right side of the front porch when tested were elevated (21% +/-) but still in the same range as the initial inspection; moisture typically is indicated as potentially excessive and/or elevated requiring additional evaluation or repair when it is at sustained levels >17%.

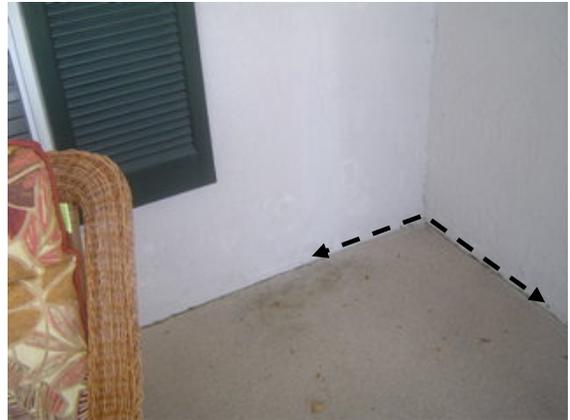
Front corner area of interior room adjacent to the area of water intrusion below the gutter on the right side of the front porch.

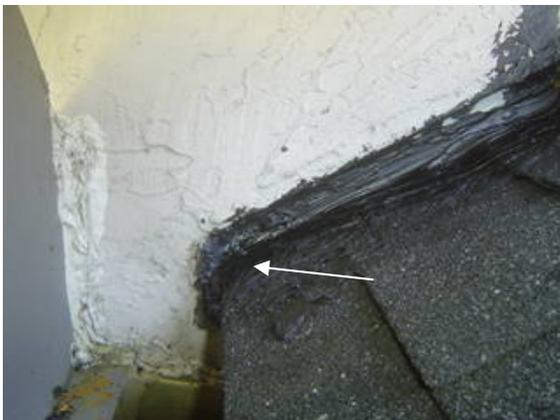
Close look at heavily tarred area of "kick out" flashing where it is suspected water intrusion was initially occurring.

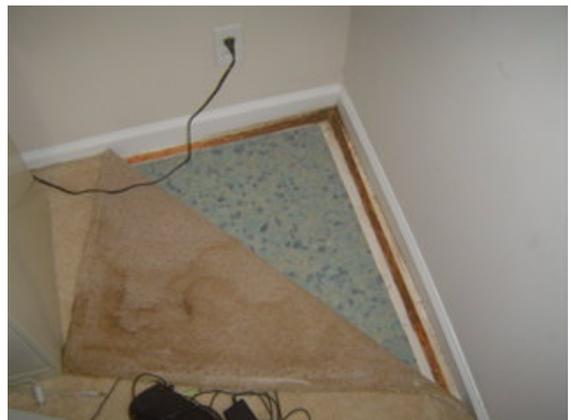
When carpet was pulled back tack strips were discolored from moisture exposure,

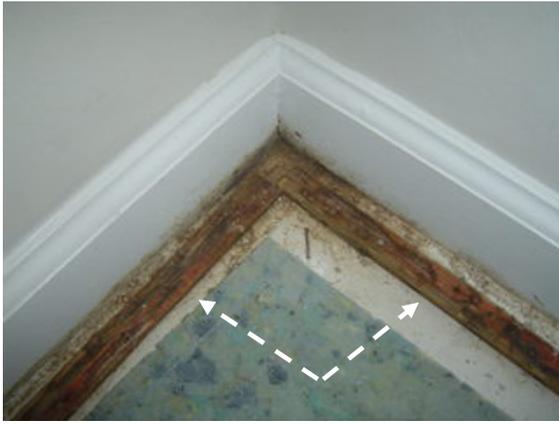
Close look at discolored tack strips.

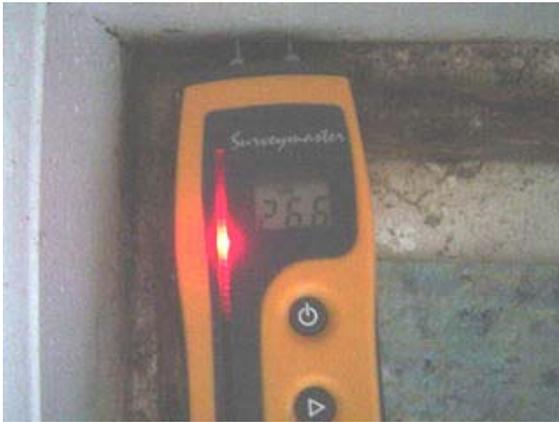
Moisture levels were elevated (17% +/-) in the ¼-round trim and baseboards at the corner area of interior room adjacent to the area of water intrusion below the gutter on the right side of the front porch; moisture typically is indicated as potentially excessive and/or elevated requiring additional evaluation or repair when it is at sustained levels >17%.
