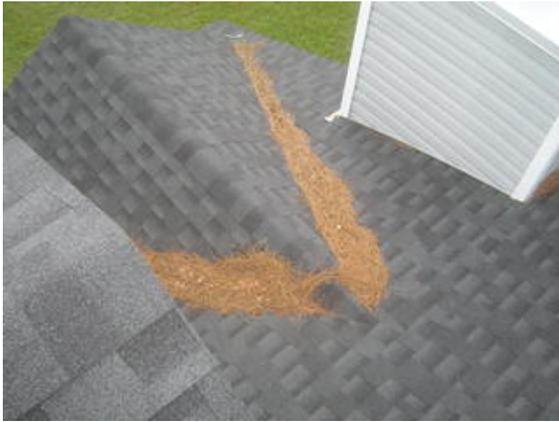
All foliage and organic debris (pine straw, leaves, etc.) should be trimmed away from siding areas (ideally 18" clearance) and off of roof. Foliage and debris promotes decay, abrasion, and damage to any component of the house it contacts. It is suggested foliage be periodically (at least annually) check and maintained as required

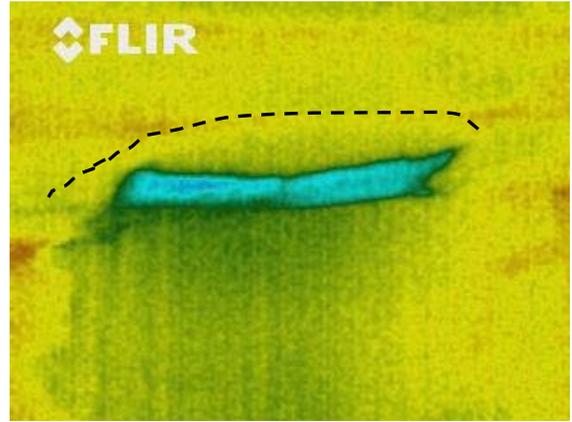
Close look at infrared imaging of the ceiling area over the chimney area; blue area of the image indicates water from active roof leak.

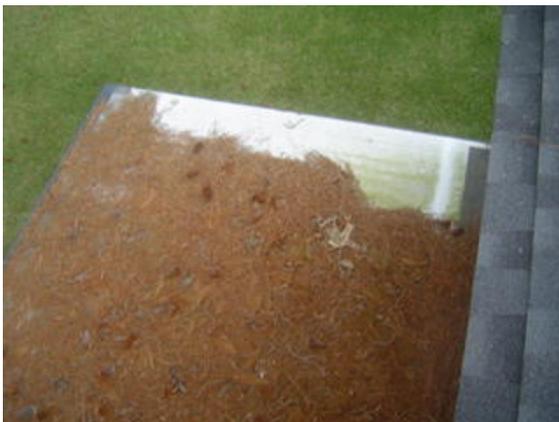
The foliage and organic debris (pine straw, leaves, etc.) on the roof promotes decay, water intrusion and insect activity.

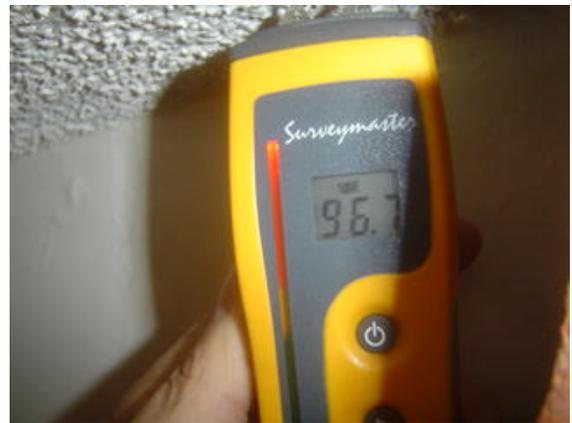
Close look at moisture meter reading (95%+) of ceiling area over the chimney; moisture levels are considered elevated and/or potentially excessive requiring additional evaluation or repair when it is at sustained levels >17%.

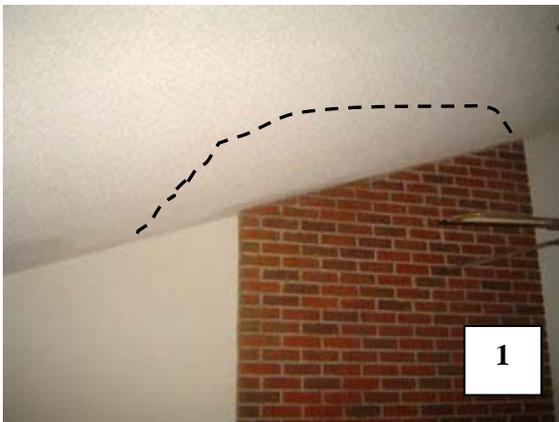
Roof leak is noted in area of the fireplace chimney. Infrared imaging and moisture testing indicates the leak is active.

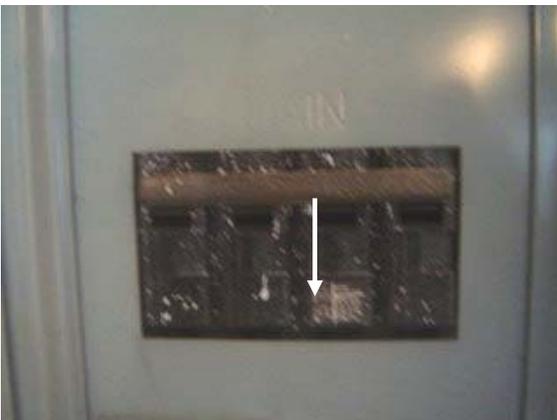
Suggest all garage, exterior, and kitchen countertop outlets be provided GFCI protection; safety/liability issue until addressed. Repairs may run upwards of \$10 +/- plus labor per outlet.

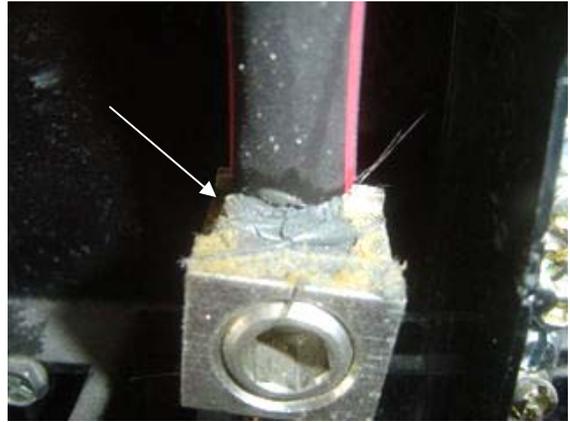
Close look at example of the aluminum wiring without the anti-oxidizing paste used at the connection.

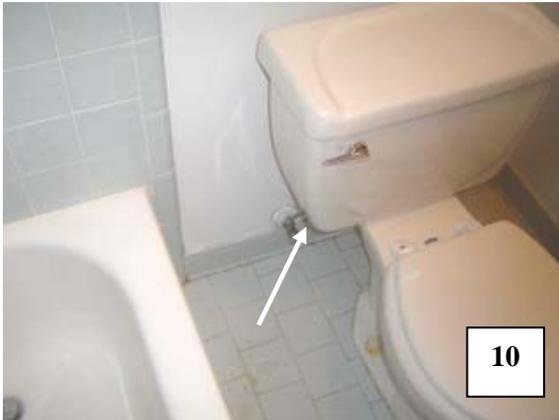
The toilet in the upstairs guest bath rocks front/back. To prevent leaks it is recommended that the wax ring be replaced and the toilet be reset

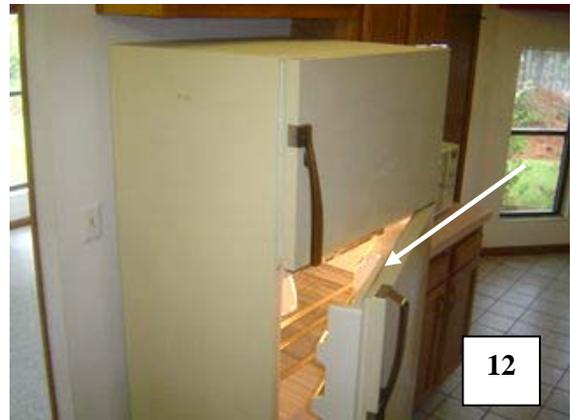
Close look at failing seal on the refrigerator door.

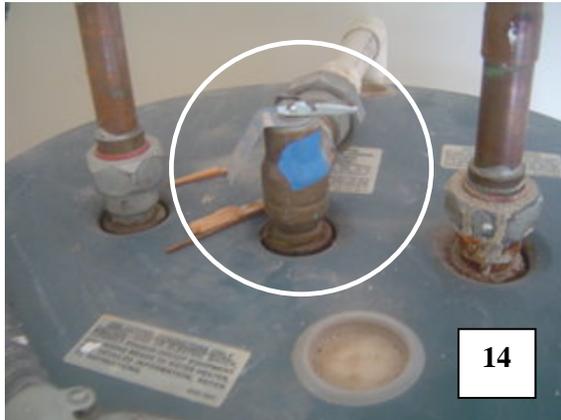
There is no catch pan under the water heater. Most manufacturer recommendations call for a "catch" pan under a water heater installed on the same level as, adjacent to, or over a living area and that it drain

to an area where no damage structural or otherwise can be done if the water leaks. In current installation if water heater fails and leaks water may run into the house under the wall of the garage. Concern is for damage to the structure (sill plates, framing), interior living area (carpets, drywall, etc.) and/or microbial/fungal growth (mold). It is suggested manufacturers' installation instructions be consulted (refer to CAUTION note in the "Location" section of the RUUD/Rheem manual), this condition, and any available remedies be discussed with the builder

If catch-pan is not installed at this time it should be installed when water heater is replaced.
