**Scenario # 1;** Infrared imaging used to determine water intrusion at improperly installed flashing at a roof/siding transition.

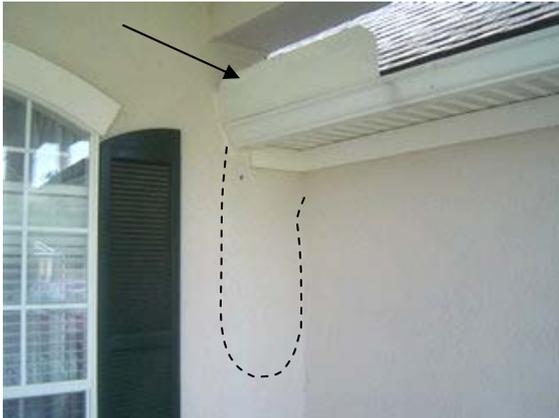
The flashing at the lower roof/siding transition on the right side of the front porch terminates behind the stucco; flashing should have a “kick out” directing water from the wall.

There is also minor stucco cracking noted in the wall below the area in question; suspect stucco cracking caused by expansion of the wood sheathing under the stucco allowed by the water intrusion at the flashing.

If invasive inspection is not performed or indicates no interior wall damage it is suggested that kick-out flashing be properly installed, stucco cracking be sealed, and area monitored for any additional failure and corrective action taken as required.

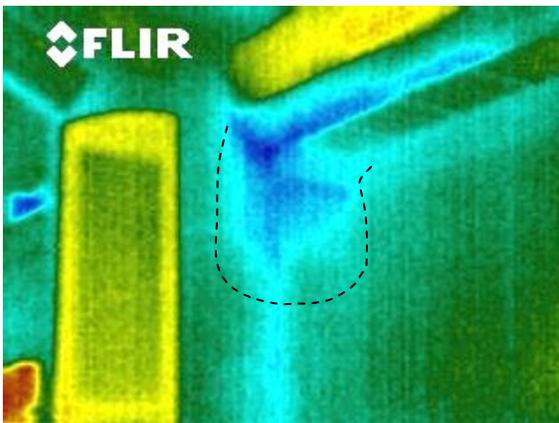
When infrared imaging was performed on the area the temperature variations would indicate possible water intrusion in the stucco below the area of improper flashing; blue color indicates cooler temperatures which suggest moisture.

It cannot be determined how much damage (if any) has occurred to the interior wall due to the flashing and water intrusion.

It is suggested a contractor be consulted for further evaluation and an invasive inspection be performed. A small area of drywall inside the home adjacent to the area of moisture on the outside wall can be opened, insulation and OSB sheathing can be visually inspected, repair requirements can then be determined.

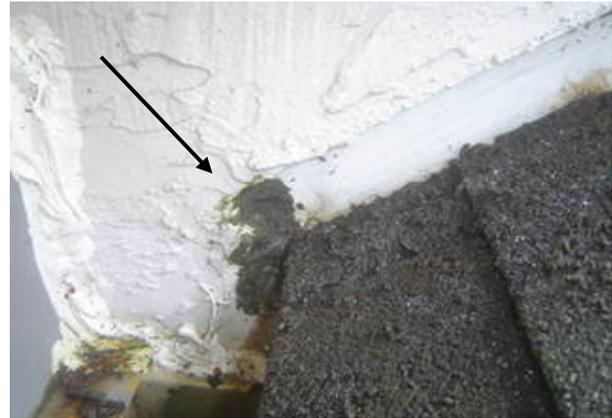
Close look at flashing of the lower roof/siding transition on the right side of the front porch that terminates behind the stucco. The flashing has been sealed with roof tar (?); seal appears to have failed.

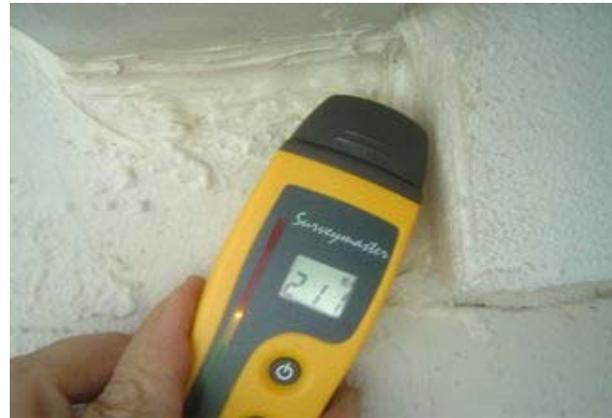
When moisture testing was performed on the stucco wall below the flashing and in the areas of stucco cracking the levels were 23 % +/-.

Interpretation of GE "PROTIMETER SURVEY MASTER" multi-function hand held moisture meter readings; 0-17 is "DRY", 17-20 is "AT RISK" and 20-100 is "WET". Readings of 17% + indicate the need for further evaluation and/or repair of damage due to water intrusion.
