Scenario # 2; Infrared used to uncover water intrusion at a windowsill inside the home.

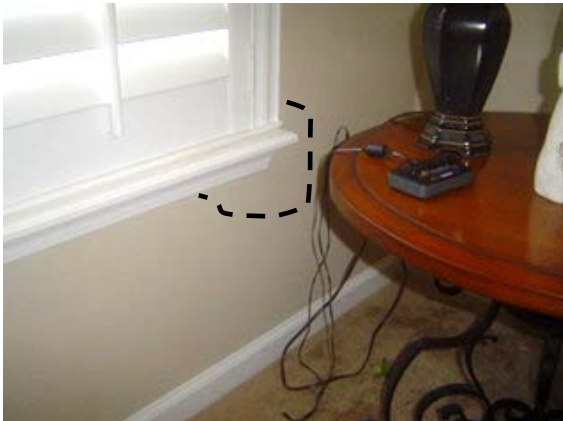
Infrared imaging and moisture testing indicates water intrusion inside the wall cavity at the right end of the windowsill in the front office.

The concern is for mold/fungal growth inside the wall cavity below the windows, drywall damage, damage to the interior wall framing components, damage to the wall sheathing behind the stucco, and major repair expense if the condition is not addressed.

It is suggested a licensed contractor and/or mpld remediation company be consulted to open the drywall, determine the extent of damage and mold/fungal growth (if any) inside the wall cavity, and repair as required.

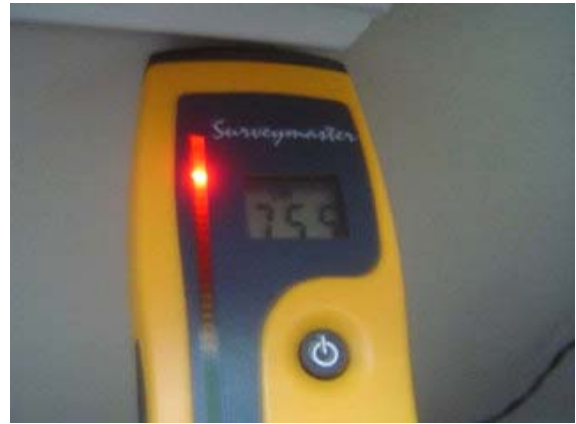
Moisture levels in the drywall below the right end of the sills were 40%-75% +.

Extreme moisture levels (75% +/-) in the drywall at the right end of the windowsill in the front office.

Interpretation of GE "PROTIMETER SURVEY MASTER" multi-function hand held moisture meter readings; 0-17 is "DRY", 17-20 is "AT RISK" and 20-100 is "WET". Readings of 17% + indicate the need for further evaluation and/or repair of damage due to water intrusion.

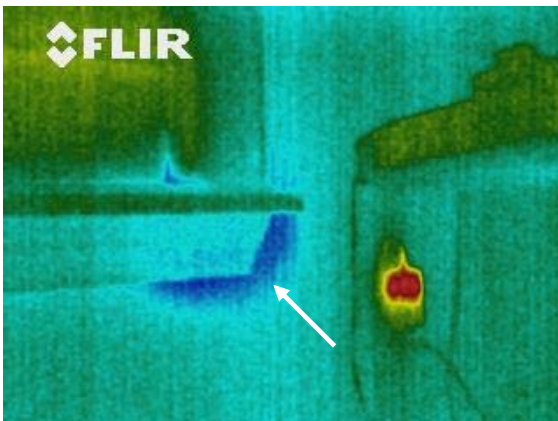
Close look at infrared imaging that indicates water intrusion at the right end of the windowsill in the front office.
