**Scenario # 3;** Infrared used to determine structural cell fill on a concrete block home

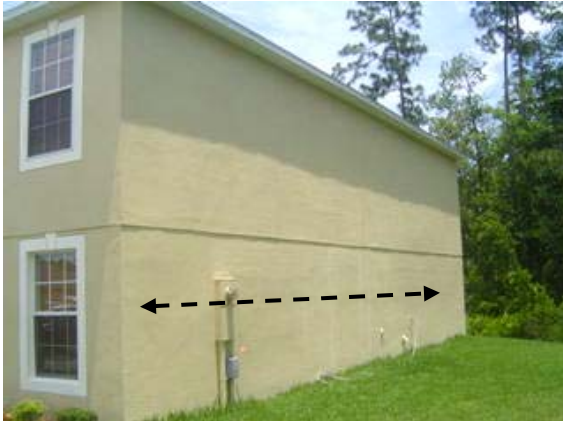
The exterior walls of the home were scanned with infrared cameras and the images indicate that the exterior walls appear to be insulated, the 1<sup>st</sup> floor concrete block wall cells appear to be filled as required, and no evidence of water intrusion was indicated at the time of this inspection.

The engineered plans must be consulted to verify actual cell block fill specs/requirements.

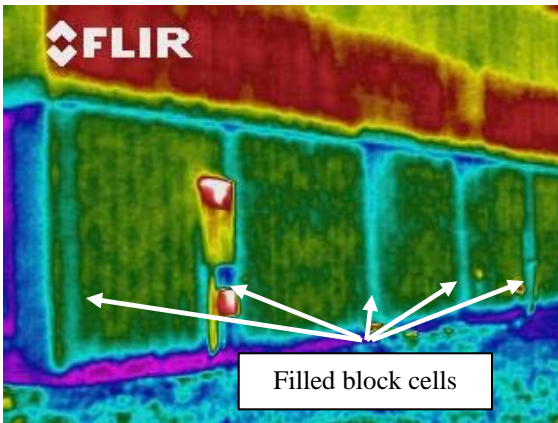
Pictured above is an example of the infrared imaging conducted on the exterior of a concrete block house.
