Scenario # 4; Infrared Imaging used to verify heat intrusion at a ceiling exhaust fan.

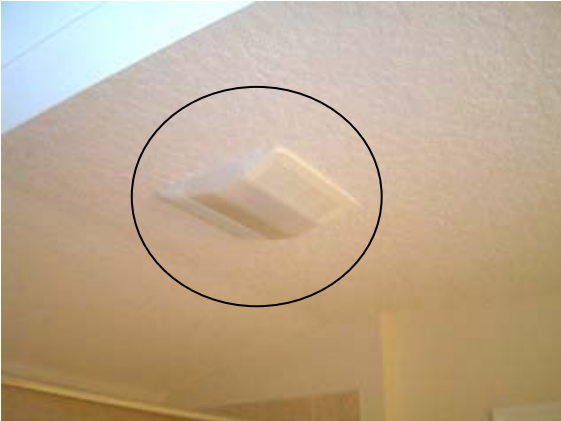
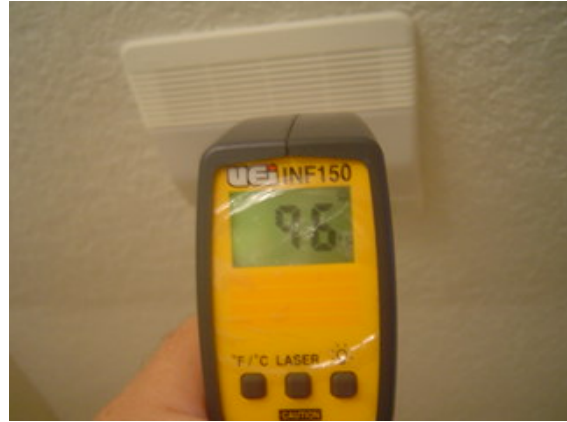
The temperature readings at the bonus room exhaust fan were 96-degrees +/-.

When tested there appears to be hot attic/exterior air (96-degrees +/-) coming in through the bonus bath exhaust fan; damper valve and/or vent line connection damaged/defective? Repair/replace exhaust fan as required.

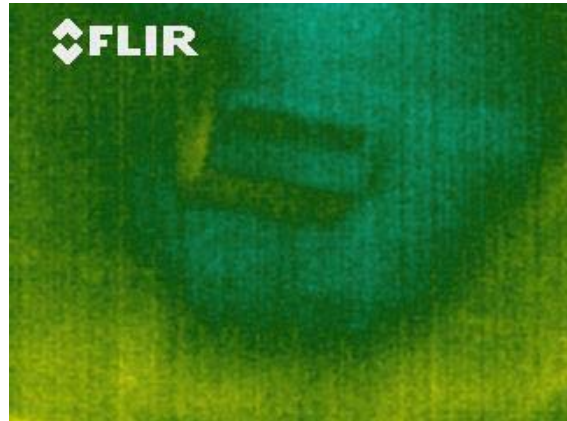
Pictured above is the infrared imaging on the downstairs bath exhaust fan; no "hot spots" noted.

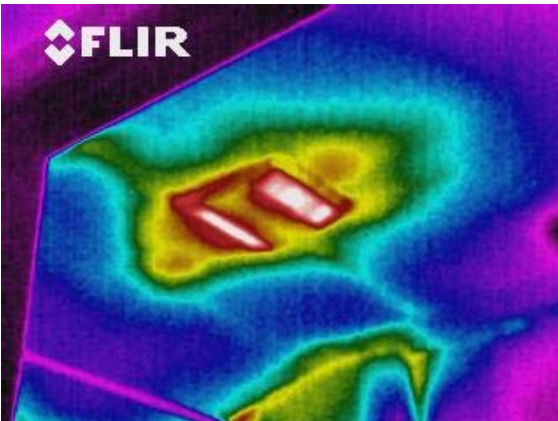
Pictured above is the infrared imaging on the bonus bath exhaust fan; red/white areas indicate high temperatures ("hot spots").
