Scenario # 6; Infrared imaging used to determine water intrusion inside a wall cavity below a window inside a shower

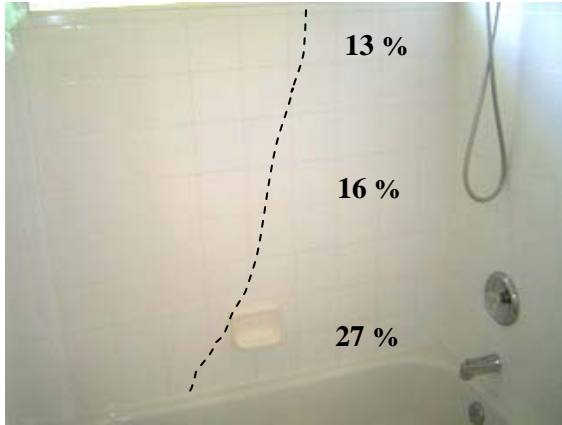
Due to the presence of the “trough” behind the Jack & Jill shower windowsill and the condition of the grout below the front edge of the windowsill moisture testing and infrared imaging of the shower wall was performed. Elevated levels of moisture were detected below the right end of the sill (13% +/-), ½-way down the wall tiles to the right of the soap dish (17% +/-), and lower wall tiles along the tub top to the right of the soap dish (27% +/-).

It is suggested a licensed contractor and/or mold remediation contractor be consulted for further evaluation and repair as required.

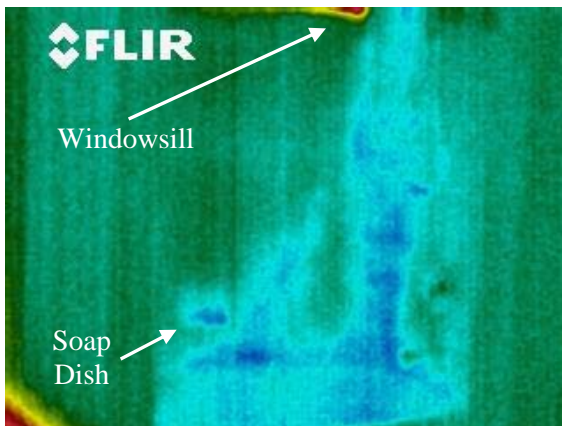
The infrared imaging showed evidence of temperature variations in the wall tiles that would indicate water intrusion corresponding to the locations of elevated moisture levels.

Infrared imaging showing temperature variations in the wall tiles (blue areas) that suggest water intrusion corresponding to the locations of elevated moisture levels.

The concern is for loose/buckling wall tiles, mold/fungal issues inside the wall, possible failure of wall framing, etc. if source of water intrusion is not addressed and maintained; repairs may require rebuilding of wall and costs may approach \$1000 +/-.

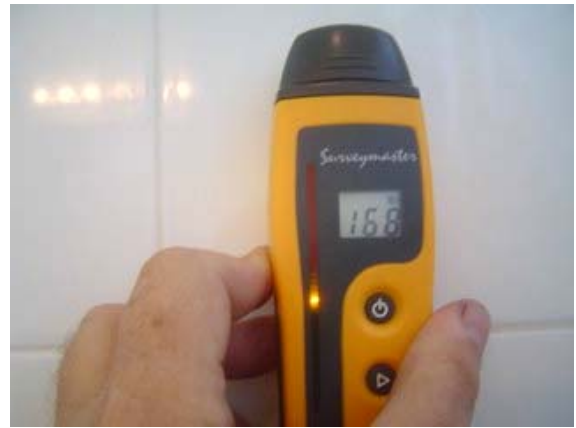
Moisture meter reading ½-way down the wall tiles to the right of the soap dish (17% +/-).

Interpretation of GE "PROTIMETER SURVEY MASTER" multi-function hand held moisture meter readings; 0-17 is "DRY", 17-20 is "AT RISK" and 20-100 is "WET". Readings of 17% + indicate the need for further evaluation and/or repair of damage due to water intrusion.

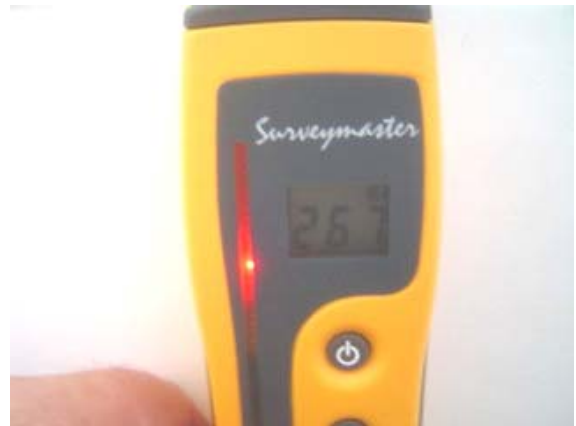
Moisture meter reading lower wall tiles along the tub top to the right of the soap dish (27% +/-).
