Scenario # 7; Infrared imaging used to detect a refrigeration/duct leak inside a wall

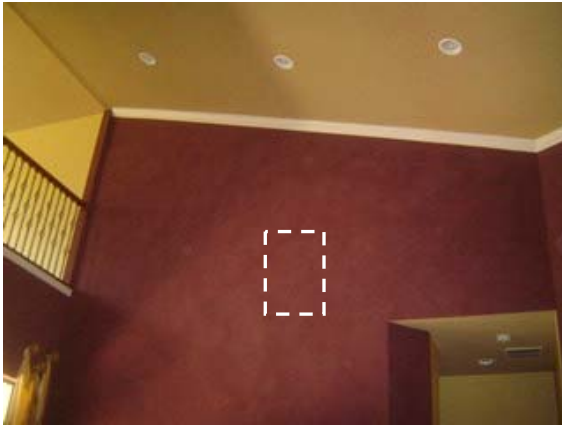
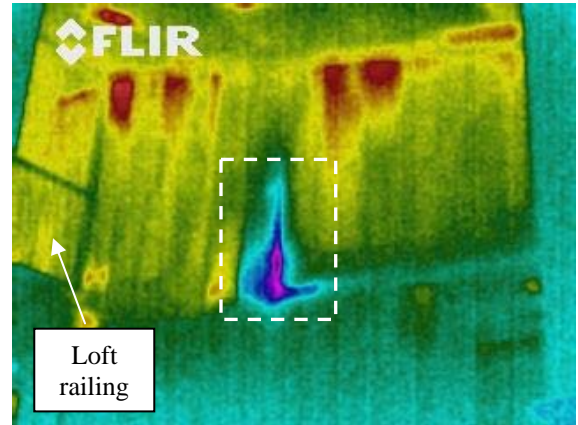
When Infrared imaging was performed a “cold spot” from an apparent refrigeration/duct leak and/or drywall covered supply duct was noted at the 1st/2nd floor transition on the middle of the living room wall between the loft and the passage to the master bedroom.

The concern is for loss of performance in the HVAC system as well as condensation forming inside the wall which may lead to wood rot, damage to wall board, and/or microbial/fungal (mold) growth with the associated damage and hazards if condition is not addressed.

Pictured above is the infrared imaging on the 1st/2nd floor transition on the middle of the living room wall between the loft and the passage to the master bedroom. The blue/purple areas indicate cool temperatures (“cold spots”); 64-degrees +/- compared with temperatures of 78-degrees +/- on rest of wall/ceiling areas.

It is suggested a licensed HVAC contractor be consulted for further evaluation and repair as required.

If mold is discovered on the rear side of the drywall a mold remediation specialist should be consulted
