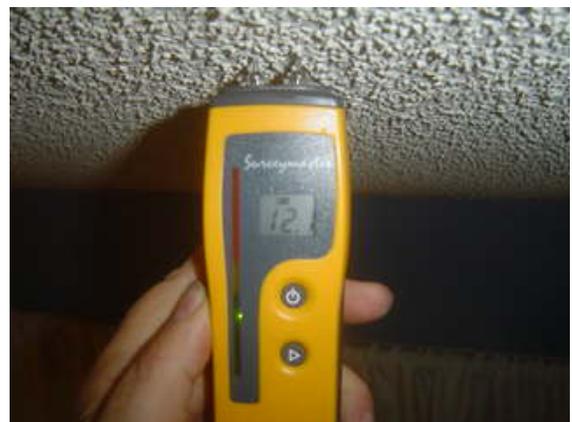
Typical moisture readings of ceiling/drywall not impacted by roof leaks were 10%-12%.

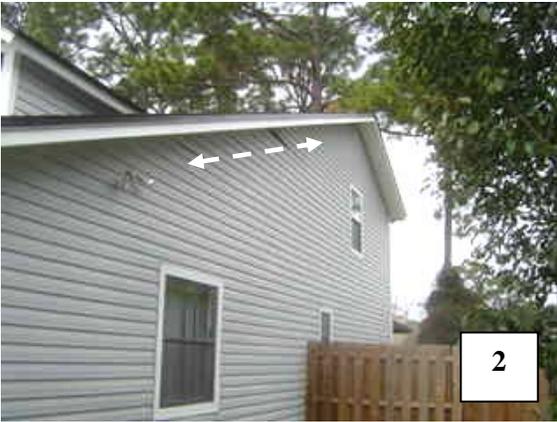
The vinyl siding along the soffit on the right side of the house is coming off; reattach siding as required.

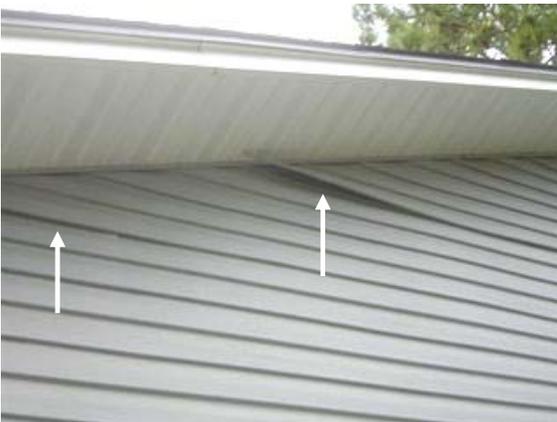
Close look at vinyl siding that is coming off along the soffit on the right side of the house.

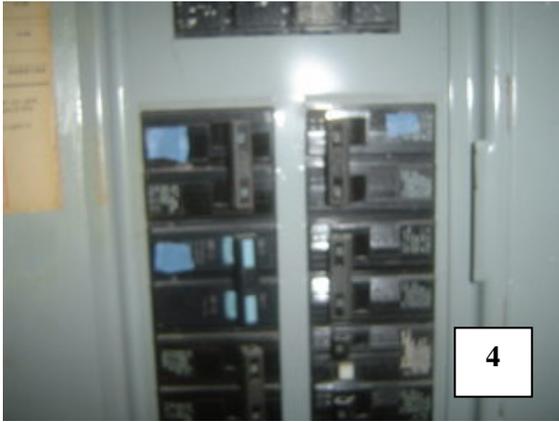
The aluminum wire connections at the range, a/c, and heater breakers do not have the anti-oxidizing paste as required (suspect wire connection on outlet behind range is in same condition); safety/liability issue until addressed.

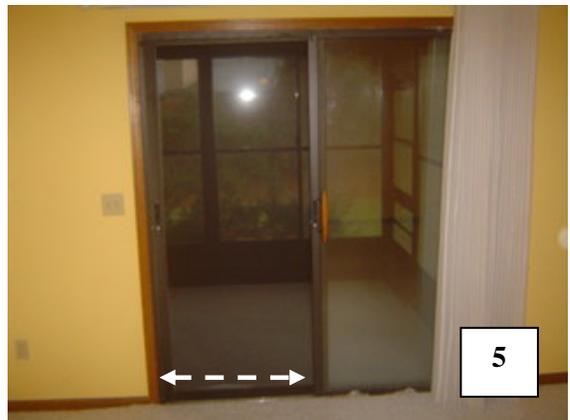
The sliding screen door in the master bedroom is torn.

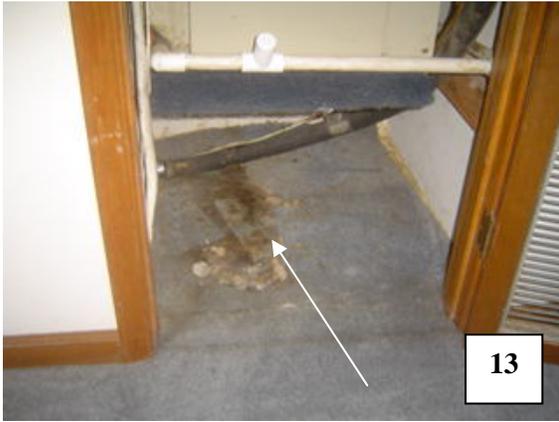
There is no catch-pan and high-level shutoff switch to control condensate overflow under the upstairs interior air-handler. If catch-pan & switch is not installed at this time they should be install when air-handler is eventually replaced.

Catch-pan and shutoff switch is available from a/c supply house or a/c dealer for \$100 +/- plus labor to install.

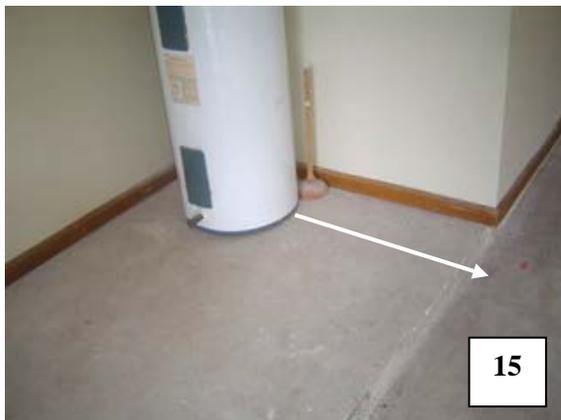
There is no catch pan under the water heater. Most manufacturer recommendations call for a "catch" pan under a water heater installed on the same level as, adjacent to, or over a living area and that it drain

to an area where no damage structural or otherwise can be done if the water leaks. In current installation if water heater fails and leaks water may run into the house under the wall of the garage. Concern is for damage to the structure (sill plates, framing), interior living area (carpets, drywall, etc.) and/or microbial/fungal growth (mold). It is suggested manufacturers' installation instructions be consulted (refer to CAUTION note in the "Location" section of the RUUD/Rheem manual), this condition, and any available remedies be discussed with the builder

If catch-pan is not installed at this time it should be installed when water heater is replaced.

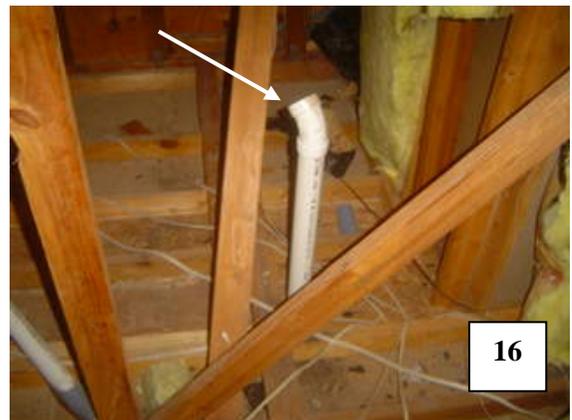
The plumbing vent stack for the downstairs 1/2-bath does not extend through the roof as is required; disconnected when home was reroofed?
